Manhole Inspection Summary

Manhole # S17EE2108MH

Location Address: **1816 KELLY AVE**

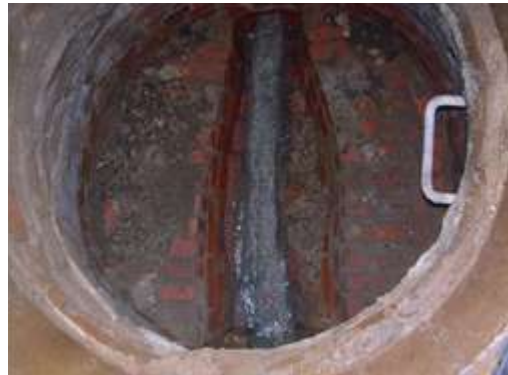
Top View

Evidence of surcharge - Bench debris.
Channel debris.

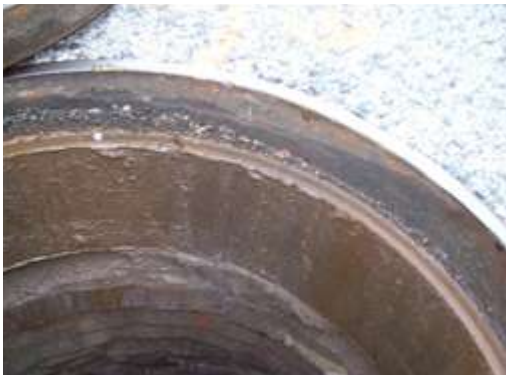
Defect

Frame leaks. Corbel and Barrel
infiltration.

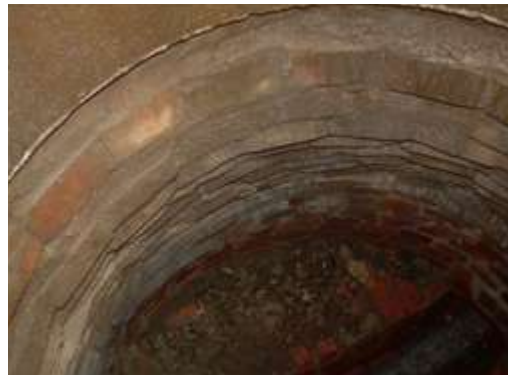
Defect

Frame leaks. Corbel and Barrel
infiltration.

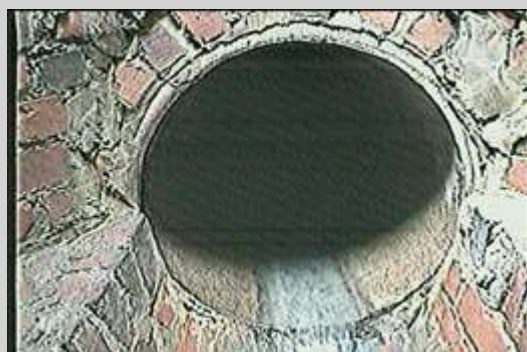
Pipe In @ 6 O'Clock

Barrel deterioration and infiltration. Channel deterioration.
